FACT SHEET. Lambda Sensors.

- Introduction

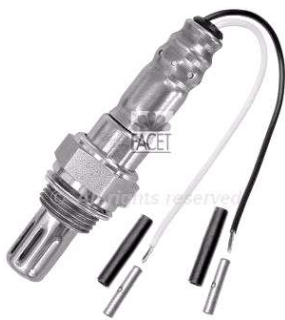
Universal type.

Direct fit type.

- a) **1 Wire:** one version only (10.7001) with its ground on the units' body, no heater.
- b) **2 Wire:** one version only (10.7002) with ground on the body and no heater.
- c) **3 Wire:** two versions, 10.7003, this has a ground on the body and a 4 OHM heater. 10.7005 is the same however the heater is 7 OHM.
- d) **4 Wire:** four versions;
10.7004 has a ground on the body and a 4-OHM heater.
10.7006 has a ground on the body and a 7-OHM heater.

The majority of oxygen sensors produced by Facet are the 'direct fit' type, these as the name suggests replace the OE unit originally fitted, without the need to cut and 'crimp' any wiring.
